Docket No. 217 – Development and Management Plan Inspection

Date: October 14, 2004

Location: Norwalk Substation Expansion

Location: Plumtree Substation Expansion , Bethel

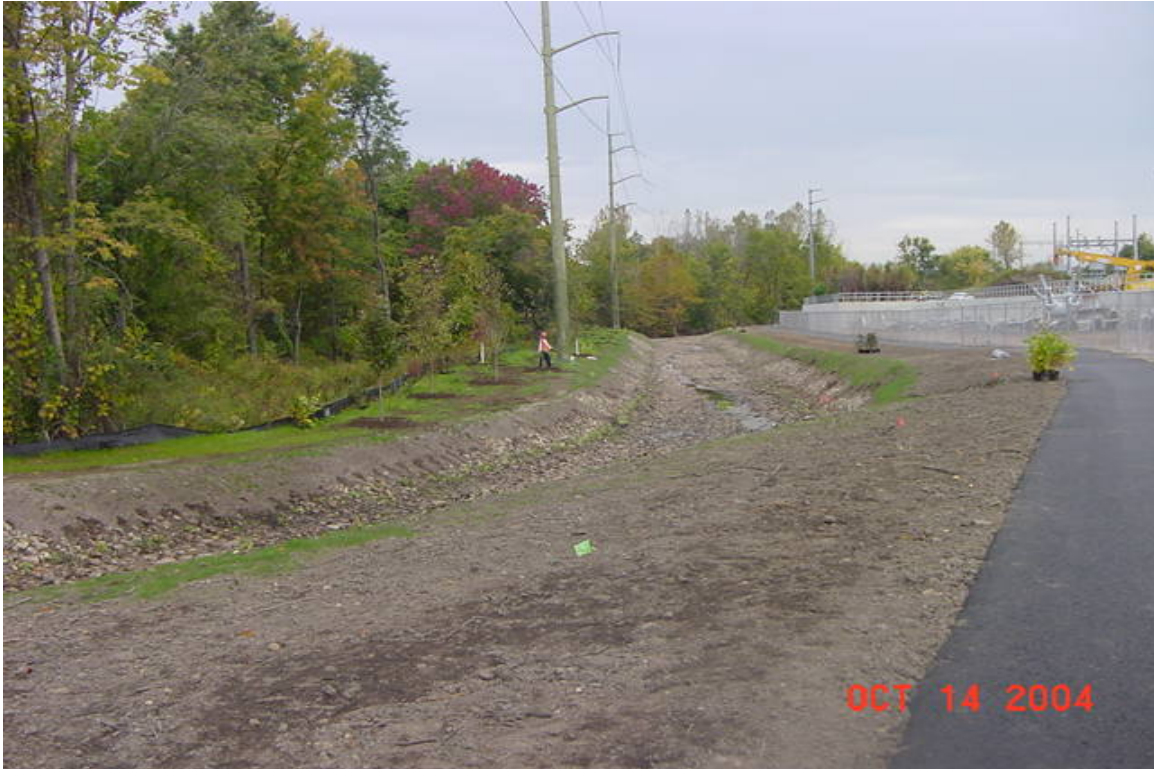
Inland Wetland and Watercourse encroachment and mitigation	- Most areas have sufficient vegetative cover but a few areas remain sparse. The areas adjacent to and within the channel especially need stabilizing cover. 9/23-10/14/04	- Continue to monitor silt fence and repair as necessary, especially in the portions closest to the river. Fence could be removed from areas with sufficient cover. 10/14/04
State species of concern, threatened and endangered species	- No species of concern are located in this area of construction.	- N/A
Vegetative clearing limits (including trees to save or danger trees noted)	-There should be no need for further clearing for most of the site. Landscaping and planting of native species along the	- Focus should be on trying to get sparsely vegetated areas to get sufficient growth before the winter. 10/14/04

Landscaping and plantings are underway along the overflow channel. Grass cover is still fairly sparse here although some regrowth has occurred. 10/14/04

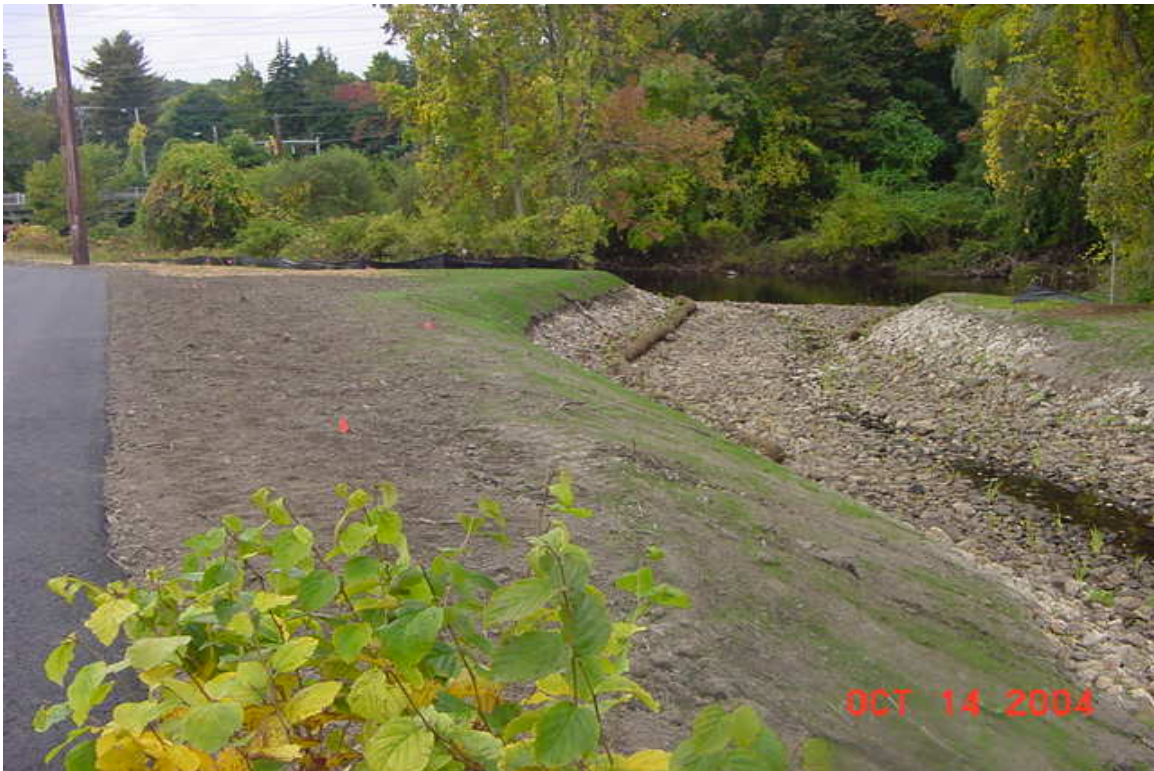
View of the southern portion of the overflow channel. Landscaping and planting is ongoing at this time along the bike path. 10/14/04

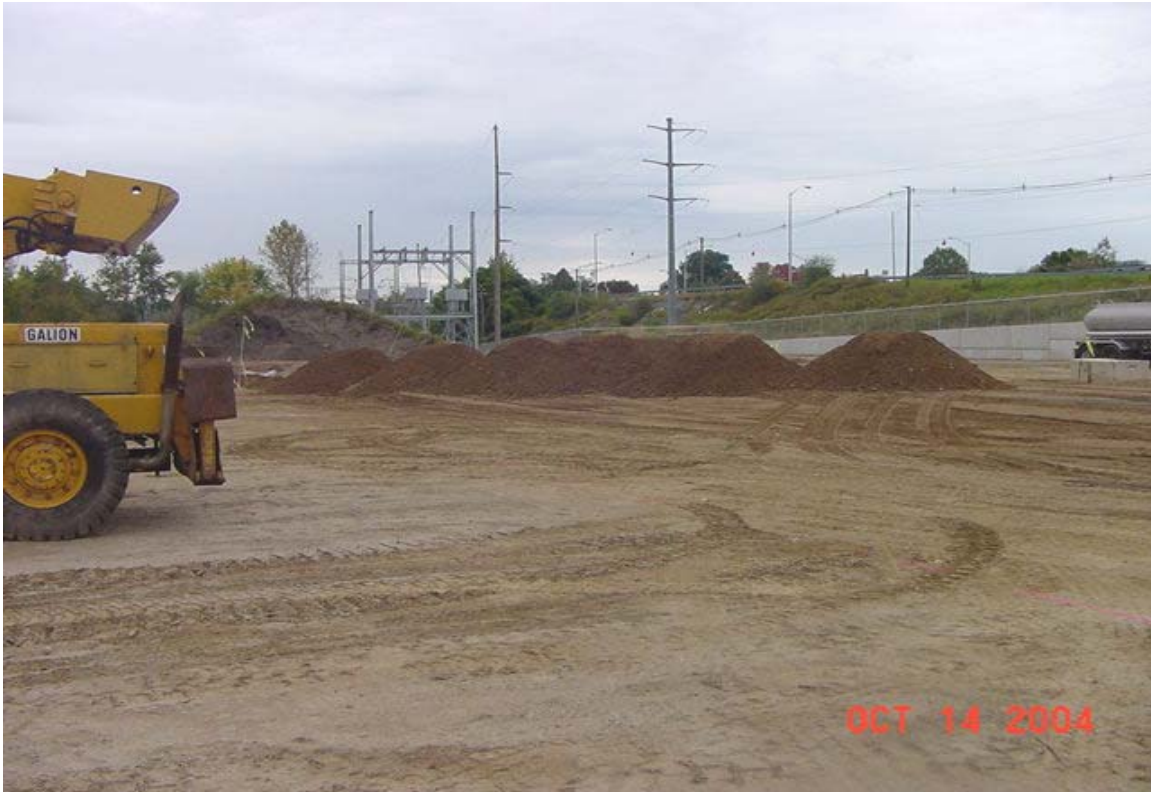
View of stockpiles on site used to bring areas to subgrade. All areas are well contained.10/14/04

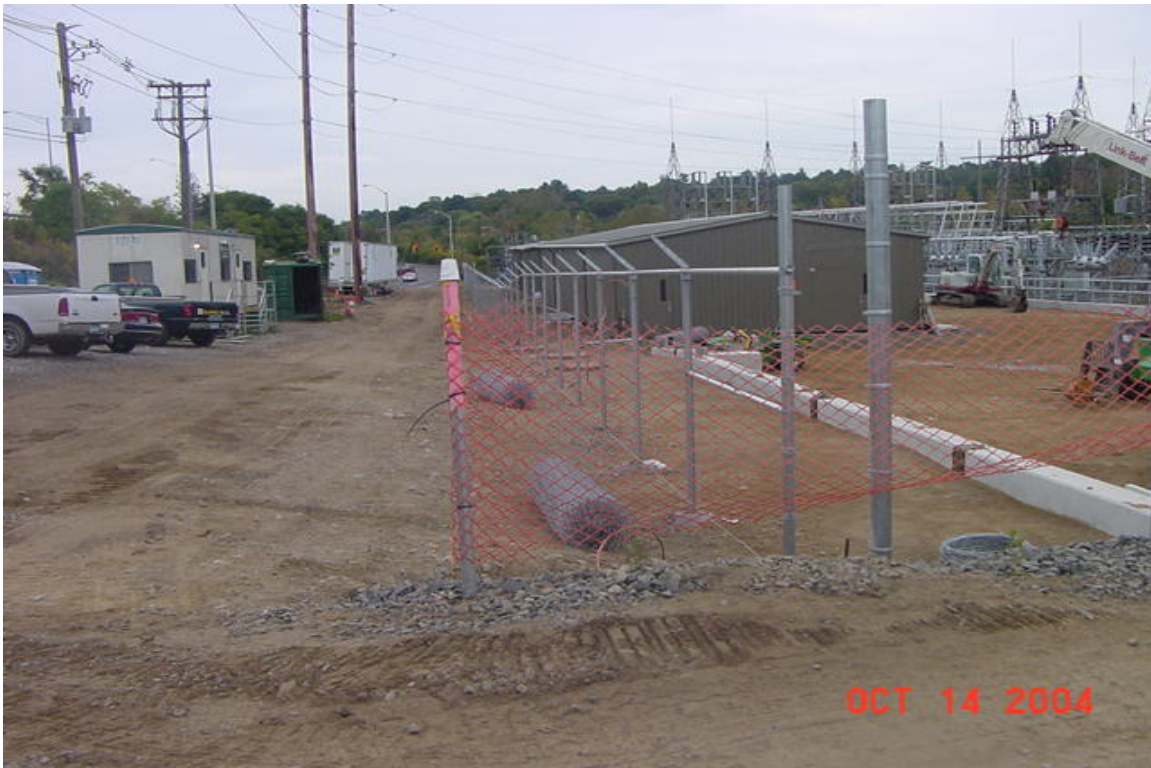
View of the fence installation work up near the Route 7 ramp and control building. 10/14/04

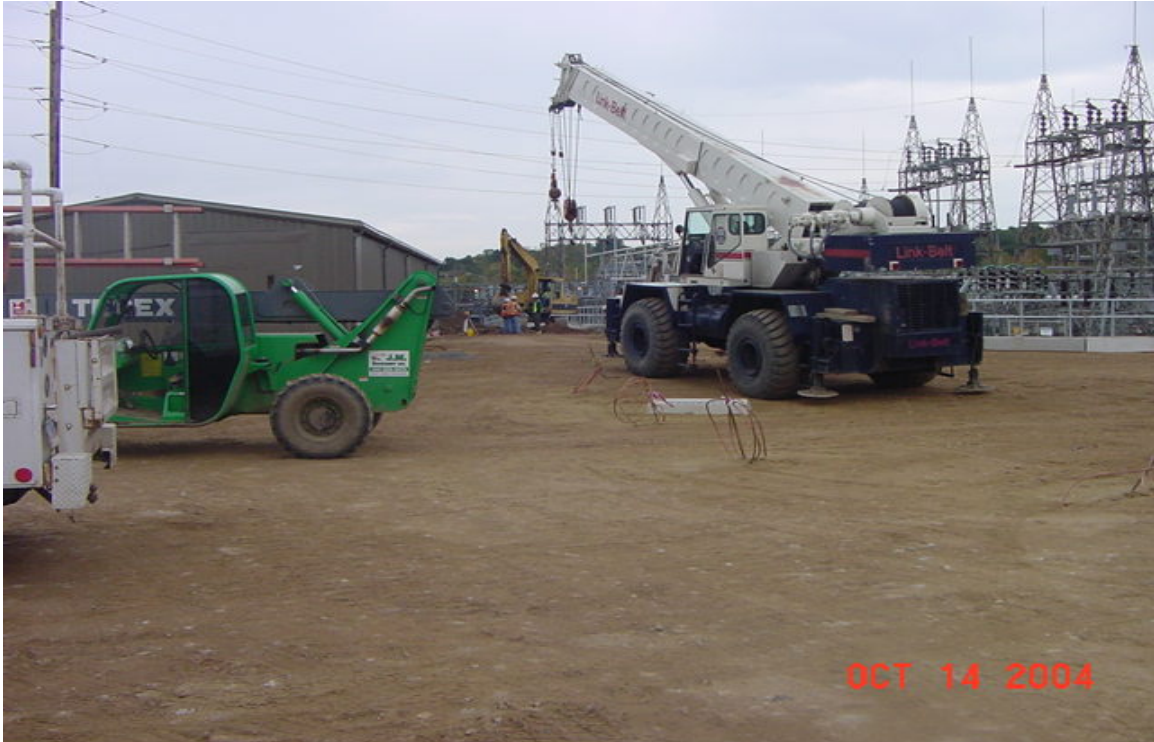
View of the site near the Route 7 ramp and the control building with the area brought nearly to subgrade. Some additional excavation will take place in this area. 10/14/04

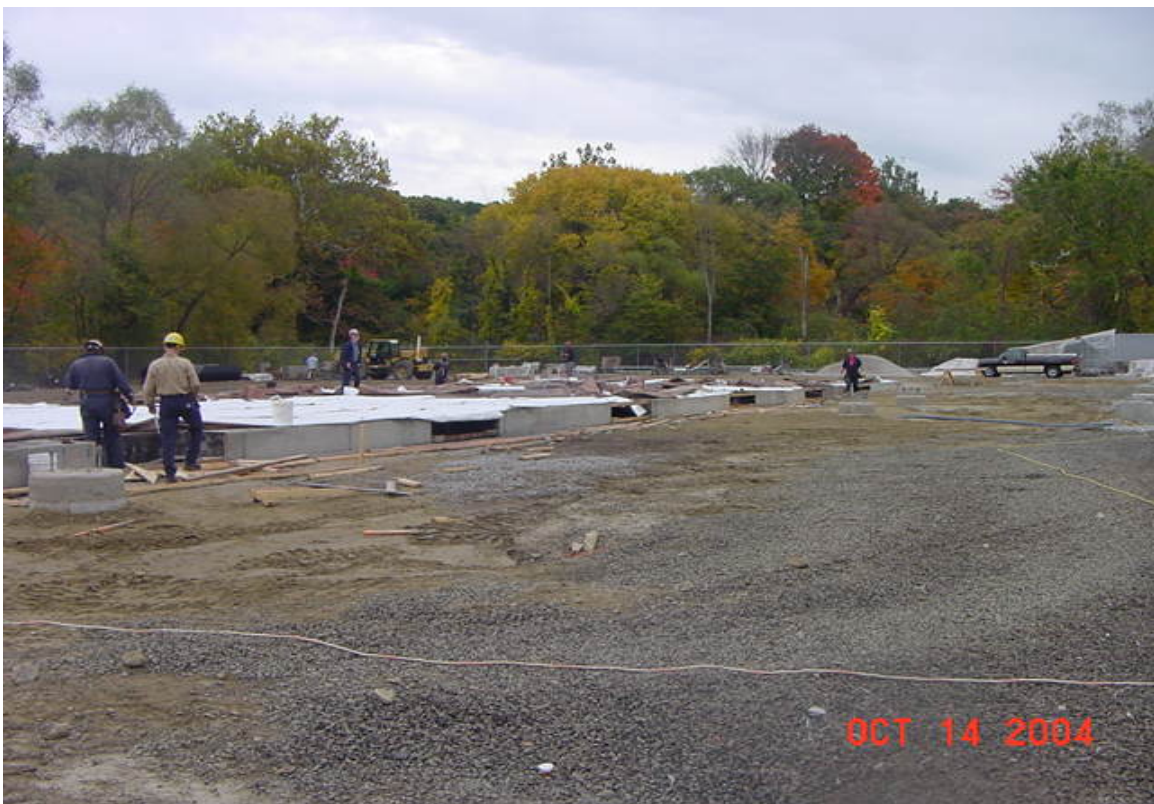
Plumtree Substation: View of the yard and the ongoing work on the GIS concrete pad. The concrete slab was poured yesterday. 10/14/04
